ADHESIVE AND PROTECTIVE CHARACTERISTICS OF CERAMIC

COATING A-417 AND ITS EFFECT ON ENGINE LIFE OF FORGED

REFRACTALLOY-26 (AMS 5760) AND CAST STELLITE 21

(AMS 5385) TURBINE BLADES

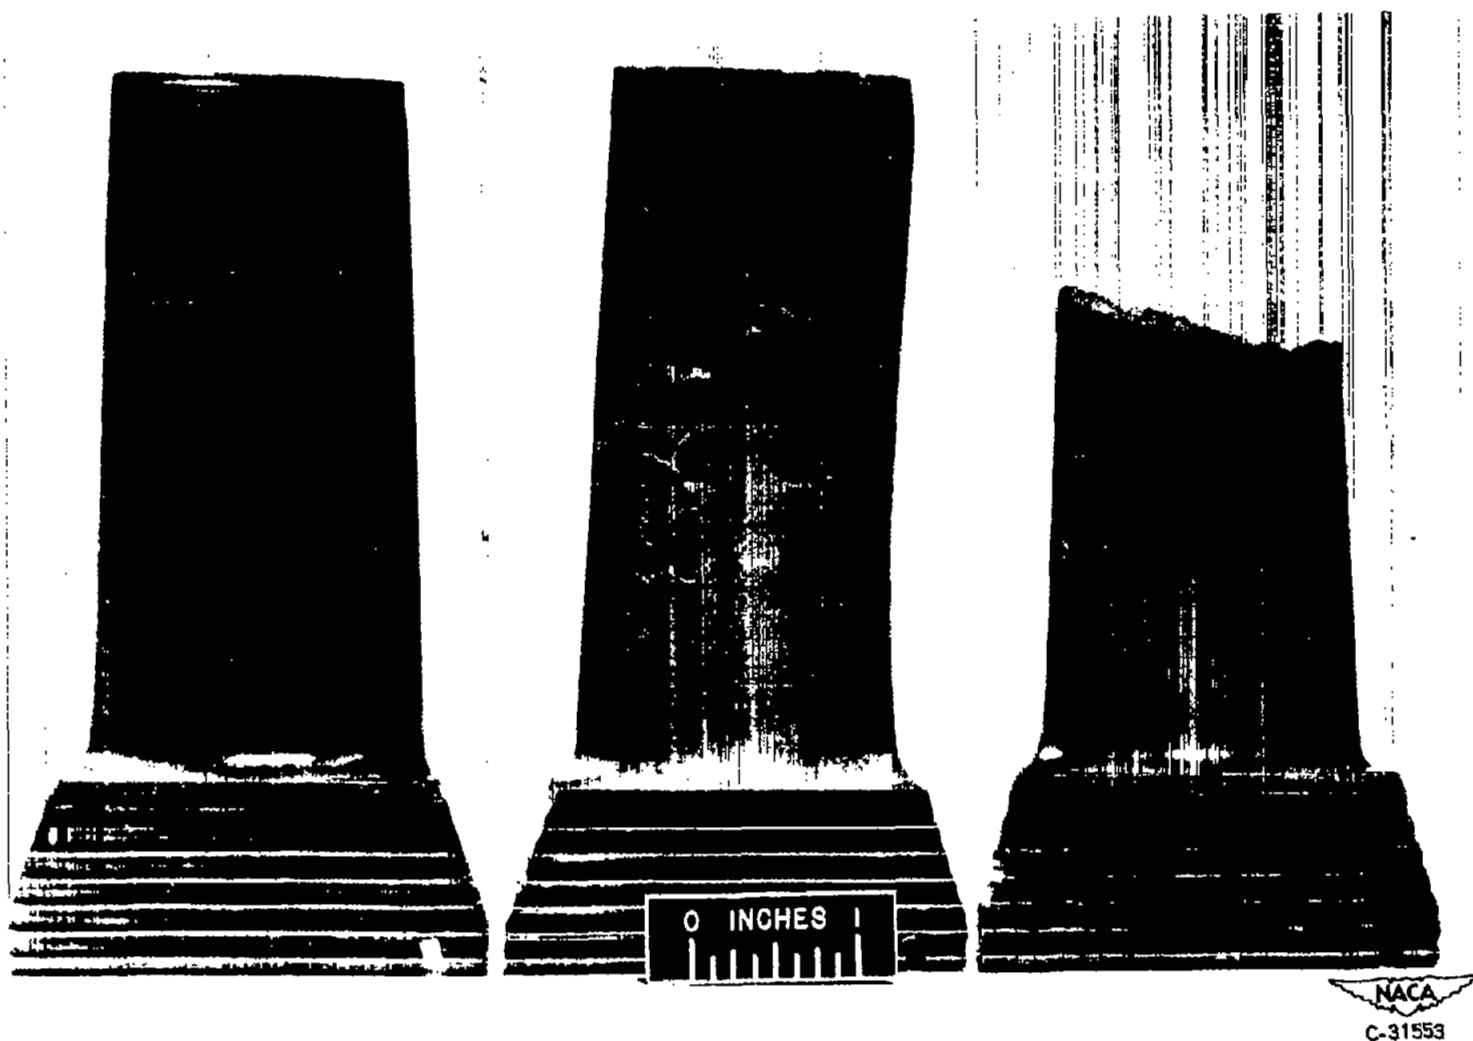
Figure 1. - Comparison of ceramic coated blades.

Appearance of blades. - Appearances of typical coated blades before and after operation are shown in figure 1. The blade in figure 1(a) is representative of as-coated blades. The coating is continuous over the airfoil surface and has a characteristic chromic oxide green color with a vitreous sheen. During operation, the sheen is removed and the color is lightened by the action of the hot gases. The blade of figure 1(b), Stellite 21, and the blade of figure 1(c), Refractaloy 26, are typical blade failures. Stress-rupture cracking of the Stellite 21 blades was not localized to the critical stress and temperature zone (2 in. above the root flat form) but became general over a wide area, giving an "orange peel" effect. Numerous grain boundaries were opened with a consequent shifting of some grains. This mass movement of metal broke the continuity of the coating, as would be expected, but the ceramic-to-metal bond remained intact. The Refractaloy 26 blade failed completely by stress rupture. The spalling of the ceramic coat noted in the center and right-hand blades was caused by fragments of prior failures impinging

on these blades. Macroscopic examination of the coated blades showed that the damage to the ceramic coating by impinging fragments was slight.

(a) As coated; unoperated.

(b) Coated Stellite 21; failed by cracking after 99.7 hours.

(c) Coated Refractaloy 25; failed by rupturing after 99.7 hours.

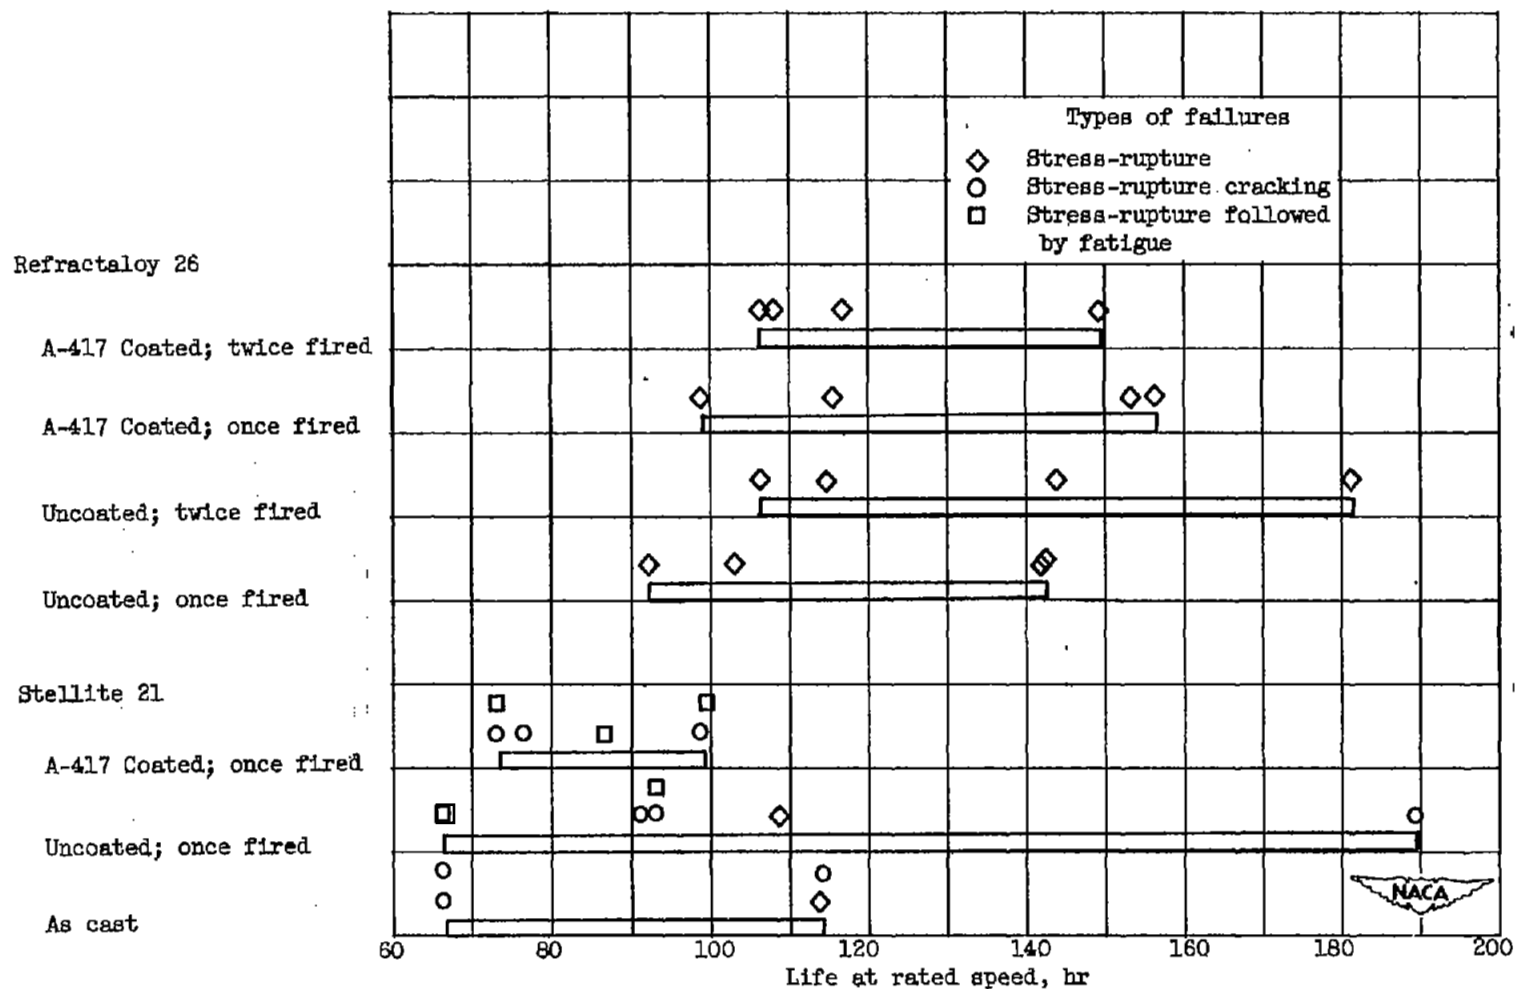
Figure 2. - Classification of A-417 coated and uncoated Refractaloy 26 and Stellite 21 blade failures.

Results of engine operation. - The results of the engine operation are plotted in figure 2, and the average life of the alloys is listed in table III. All the Refractaloy 26 blades and more than half of the Stellite 21 blades failed by stress rupture.

It is evident from these data that the ceramic coating did not noticeably improve blade performance; nor did the coated blades fail by mechanisms different from those of the uncoated blades, as the symbols of figure 2 indicate. It will subsequently be shown that the ceramic coating protected Refractaloy 26 and Stellite 21 blades from corrosion by the combustion products. In the case of Refractaloy 26, the alloy known to be susceptible to high-temperature corrosion, an improvement in performance would be expected; however, the results indicate that apparently the performance of these blades did not depend on their corrosion resistance.

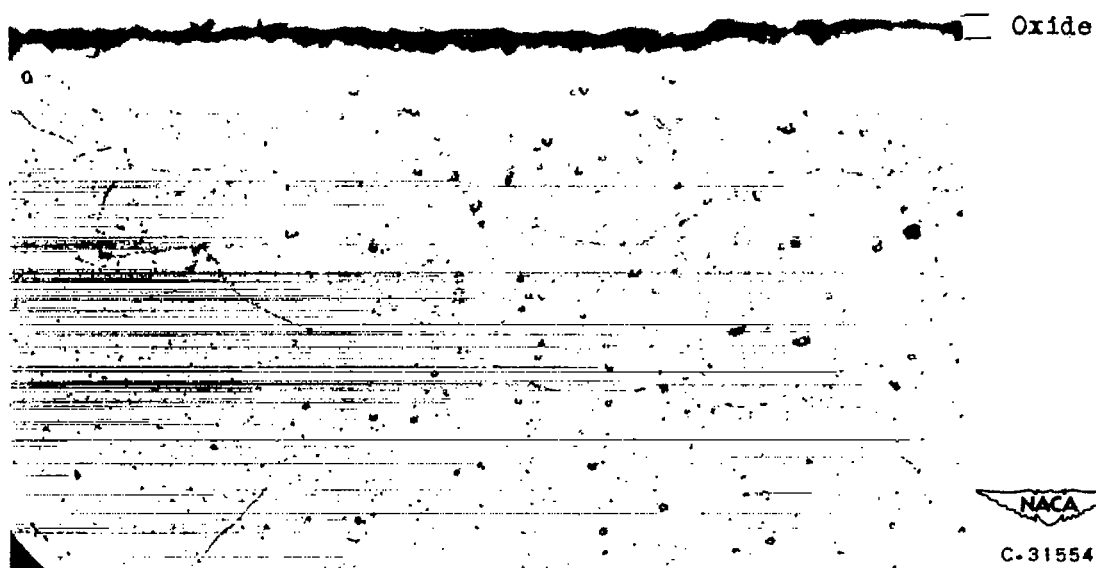
Examination of uncoated blades. - A typical oxide coating produced by solution treating and aging Refractaloy 26 is shown in the photomicrograph of figure 3. The oxide layer was approximately 0.00025 inch thick, and penetration of the grain boundaries of the recrystallized zone was observed although it is not apparent in the photomicrograph. Excessive grain-boundary corrosion of uncoated Refractaloy 26 blades operated for 106 and 143 hours is shown in figure 4. Severe corrosion of this type would be expected to lead to short operational life. However, as has been noted, failure times of coated and uncoated blades are practically the same.

Figure 3. - Oxidation of Refractalloy 26 during heat treatment. Electrolytically etch in 50-percent hydrochloric acid. X250.

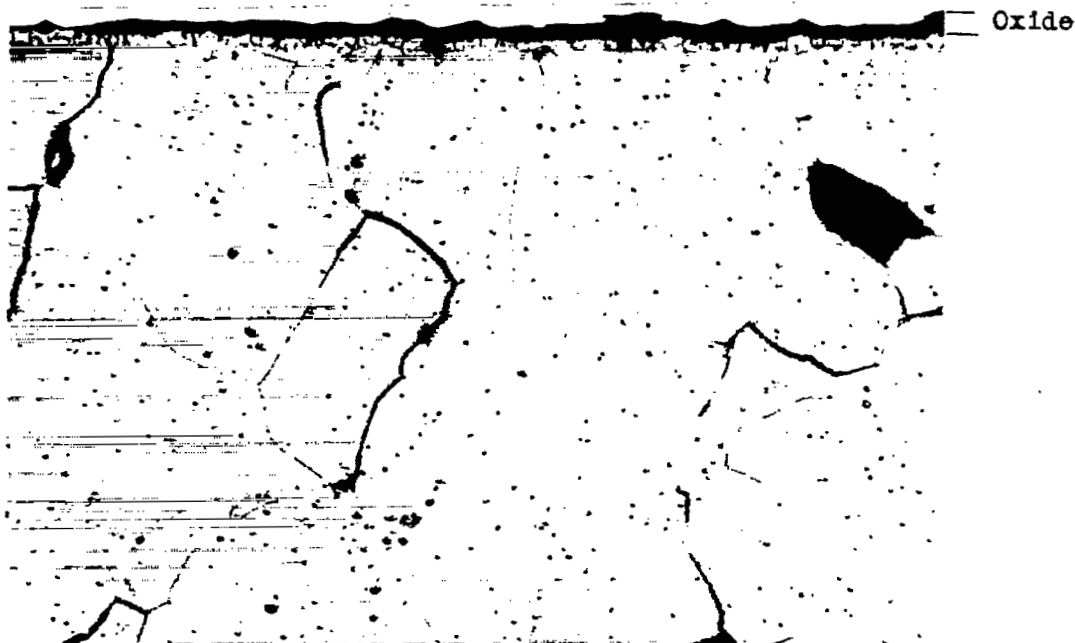
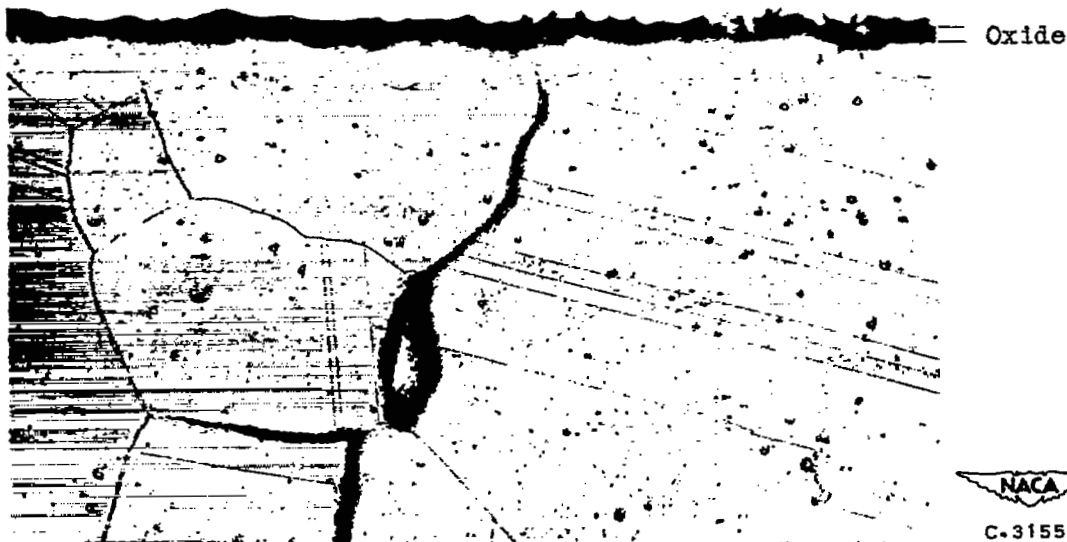
(a) Fired twice; operated 106.4 hours. Electrolytically etched in 50-percent hydrochloric acid. X100.

(b) Same specimen as in figure 4(a) at X250.

Figure 4. - Extensive grain boundary corrosion of uncoated Refractaloy 26 operated in a turbojet engine.

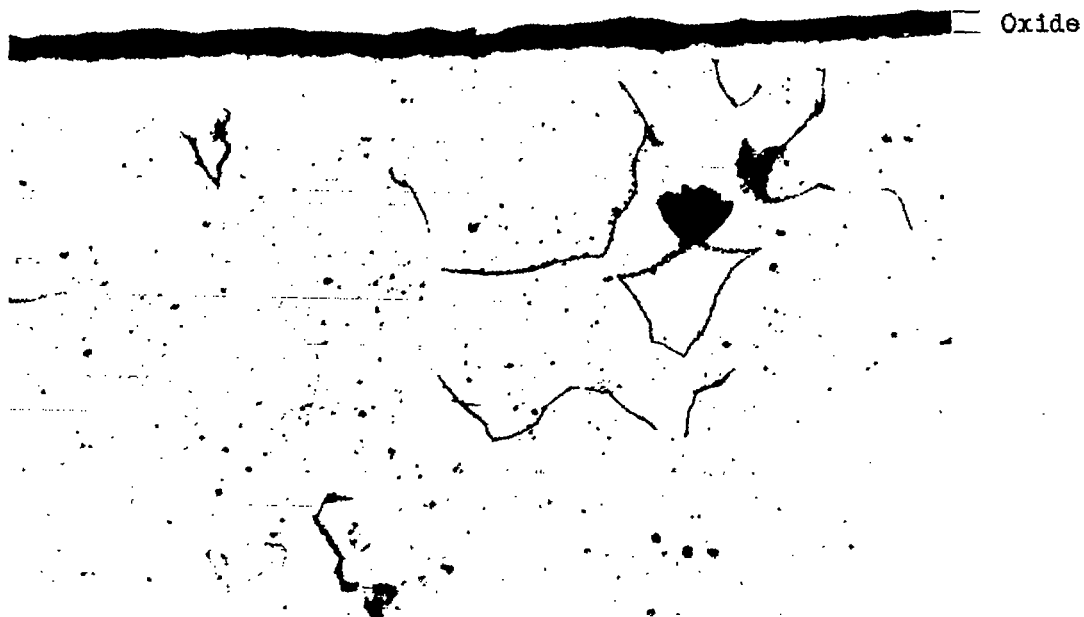
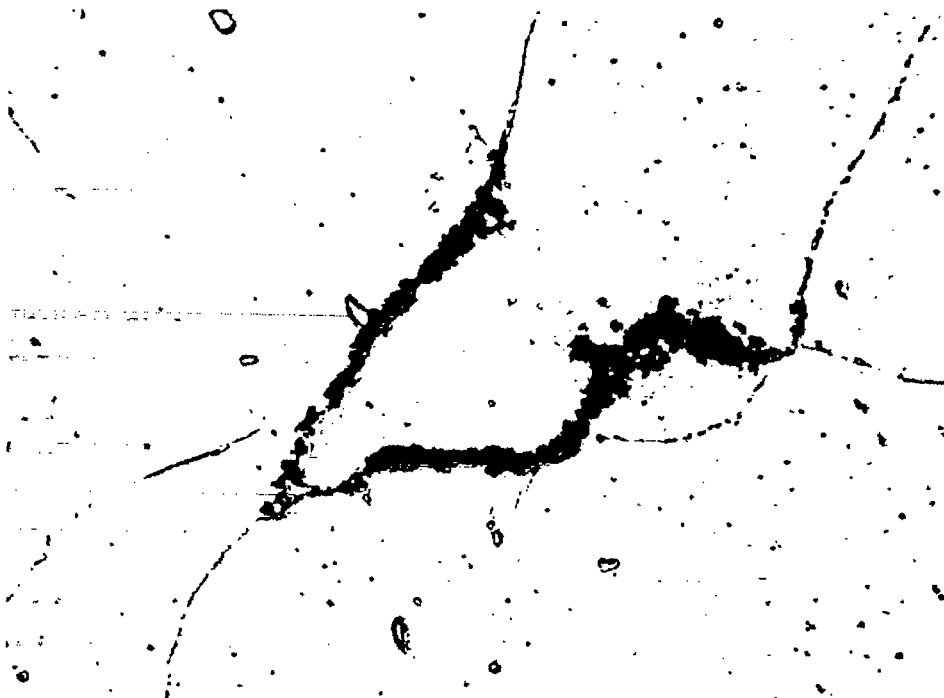
(c) Fired once; operated 142.9 hours. Electrolytically etched in 50 percent hydrochloric acid. X100.

(d) Same specimen as in figure 4(c) at X750.

Figure 4. - Concluded. Extensive grain boundary corrosion of uncoated Refractaloy 26 operated in a turbojet engine.

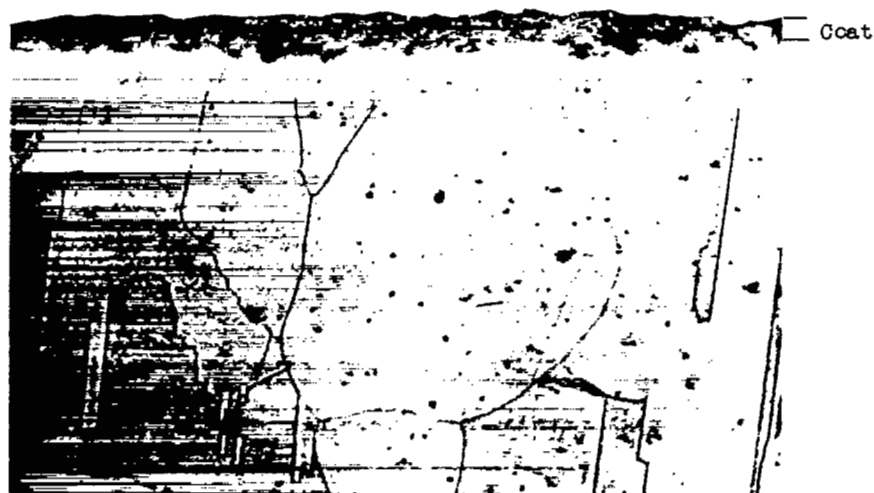
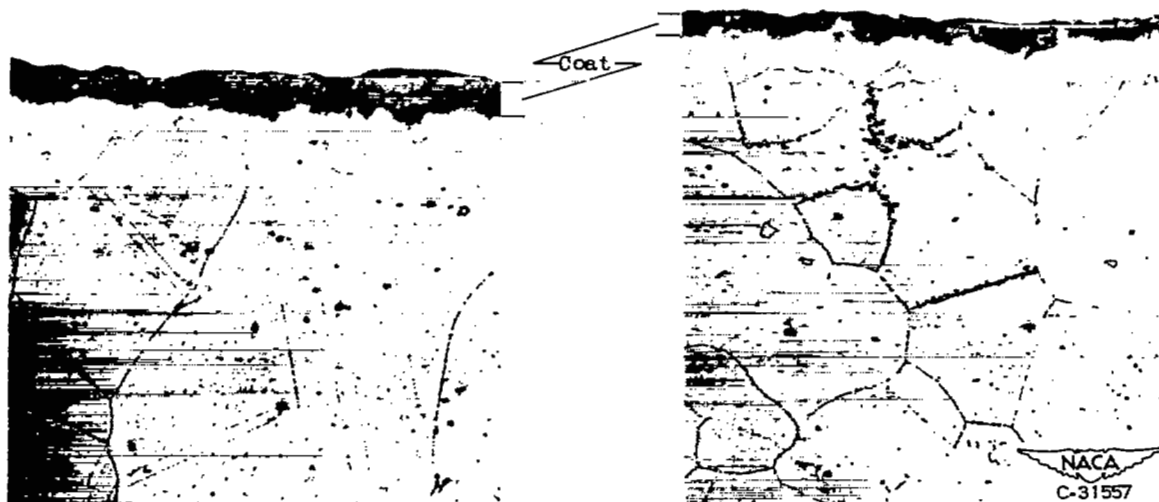
Figure 5. - Ceramic-metal interfaces of coated Refractaloy 26 before and after operation in a turbojet engine. Photographed at X250; reduced 23 percent in reproduction.

Examination of coated blades. - Metallographic examinations of specimens cut from portions of operated blades that did not elongate severely showed that the ceramic coating prevented corrosion and adhered well to the surfaces of the metal (fig. 5). Some of these sections, which were protected from corrosion, were obtained from the immediate vicinity of the fractures, in the hottest, most critically stressed zones of the blades. In other specimens, in areas near the fractures, corrosion was observed, but the fracturing of the ceramic that permitted this corrosion almost certainly occurred after the blade alloy entered third-stage creep.

(a) Fired once; unoperated. Electrolytically etched in 50-percent hydrochloric acid.

(b) Fired once; operated 99.2 hours. Electrolytically etched in 50 percent hydrochloric acid.

(c) Fired twice; operated 149.5 hours. Extensive precipitation in grain boundaries. Electrolytically etched in 50-percent hydrochloric acid.

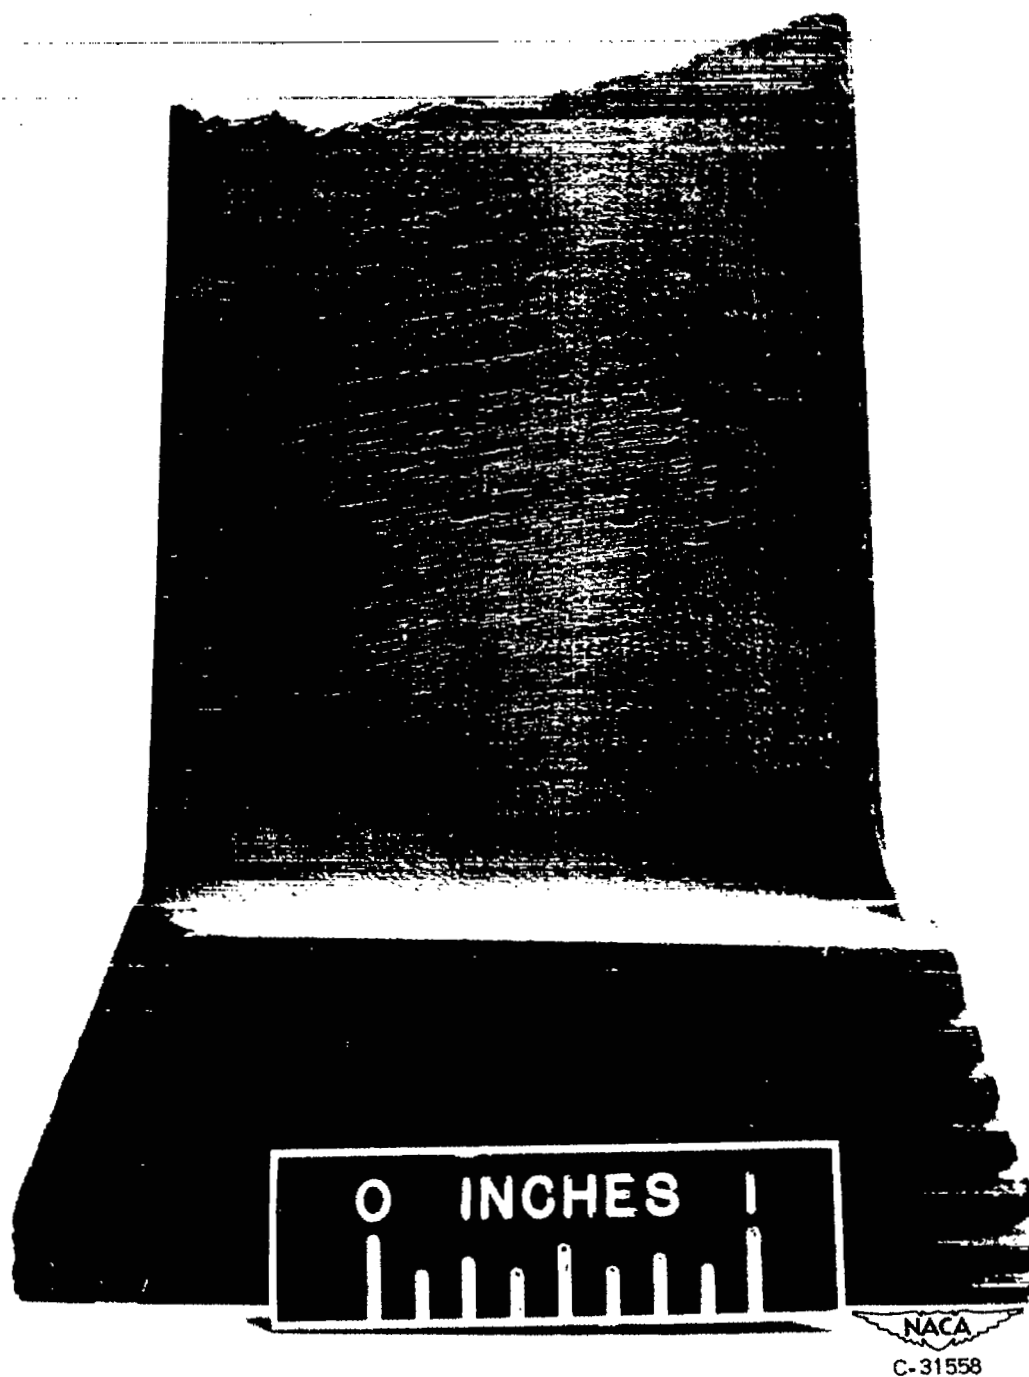
Three of the four blades which had a coat thickness of 1.0 to 2.0 mils developed striations on the concave face during operation (see fig. 6). The striae probably formed in these thick coatings during cooling at shut downs of the engine, which produced an elastic recovery of the base metal.

Figure 6. - Striations present in thick coating (1.0 to 2.0 mil) on Refractaloy 26 after 153.6 hours of engine operation.

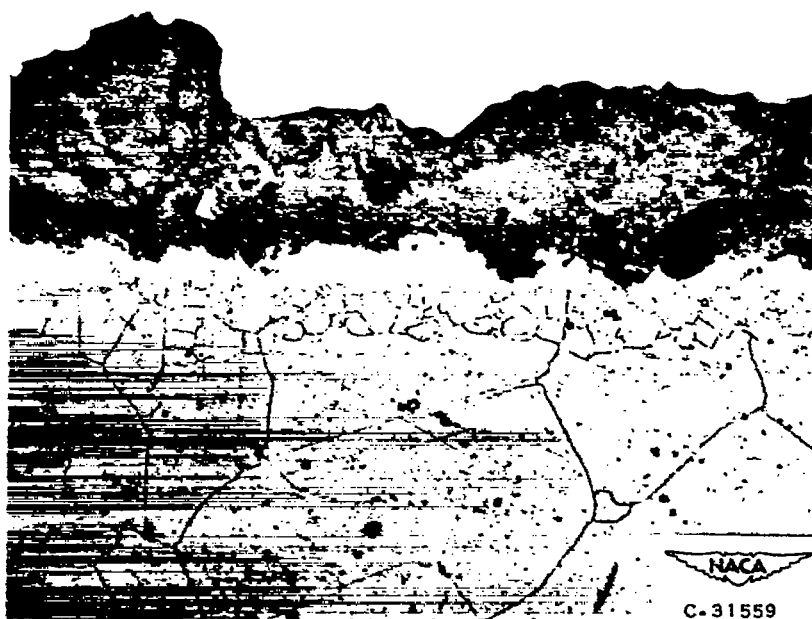
Figure 7. - Ridges produced in thick ceramic coating on Refractaloy 26 during engine operation.

The ceramic is believed to have flowed plastically as the metal elongated both plastically and elastically during heating. On cooling, the metal recovers by a greater amount than the ceramic. To relieve the compressive stresses, ridges are built up on the outer surface by plastic movement of the coating. This analysis is substantiated by an examination of a cross section of the striae. Photomicrographs of this section (fig. 7) show a ridge and valley on the coat surface, but no visible change occurs to the ceramic-metal interface.

(a) Unetched. X100. Polarized light.

(b) Same specimens above electrolytically etched in 50-percent hydrochloric acid. X250.  
Recrystallization zone produced during heat treatments.

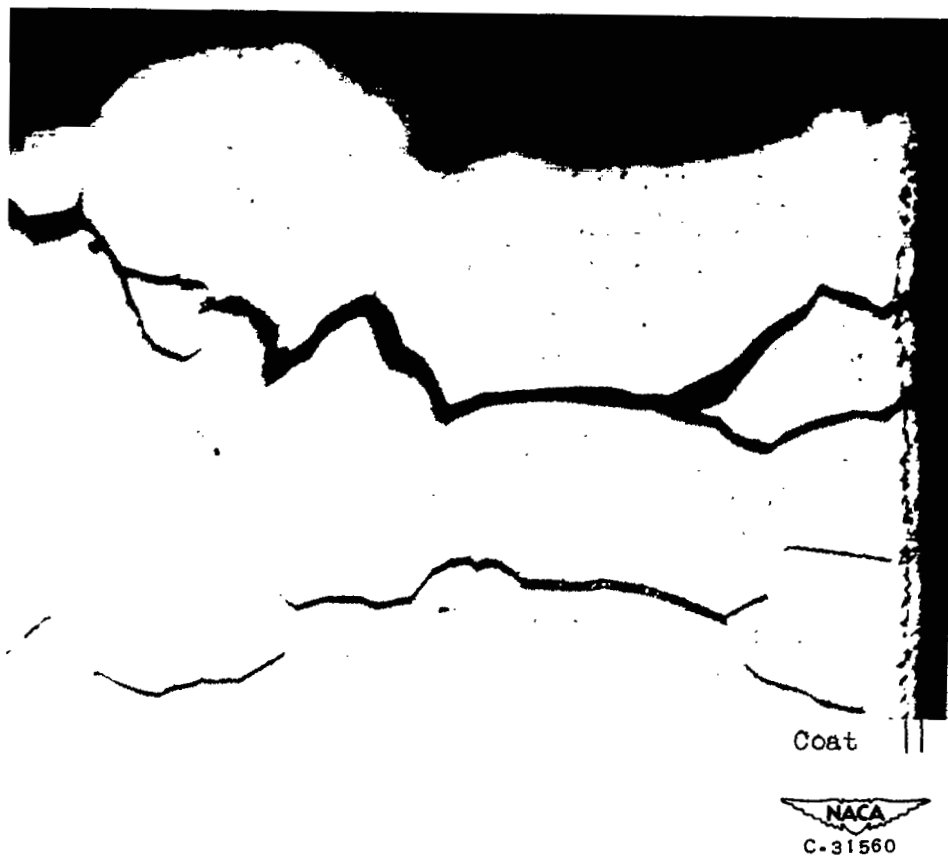
The failure zone shown in figure 8 (coated Refractaloy 26) is typical of all failures in this alloy. The mode of failure is stress-rupture, which propagates intergranularly. Oxidation of the grain boundaries occurs only after the coating is broken by excessive elongation (stress-rupture).

Figure 8. - Typical intercrystalline failure in coated Refractaloy 26 occurring during operation in a turbojet engine. Electrolytically etched 50-percent hydrochloric acid. X100.
